Inspection Report

Minerals Regulatory Program

Mine Name: Cedarstrom Calcite Mine	Permit Number: S/49/0012	Permit Fees: Paid		
Operator Name: Interstate Brick Co.	Inspection Date: 02/27/2014	Bond Amount: \$25,200.00		
Inspector(s): A. Abate	Time: 9:30 AM	Bond Escalation: 10/21/14		
Others: C. Ennis, L. Botellio - AMES Constr.	Mine Status: Inactive			
Elements of Inspection		Evaluated	Comment	Enforcement

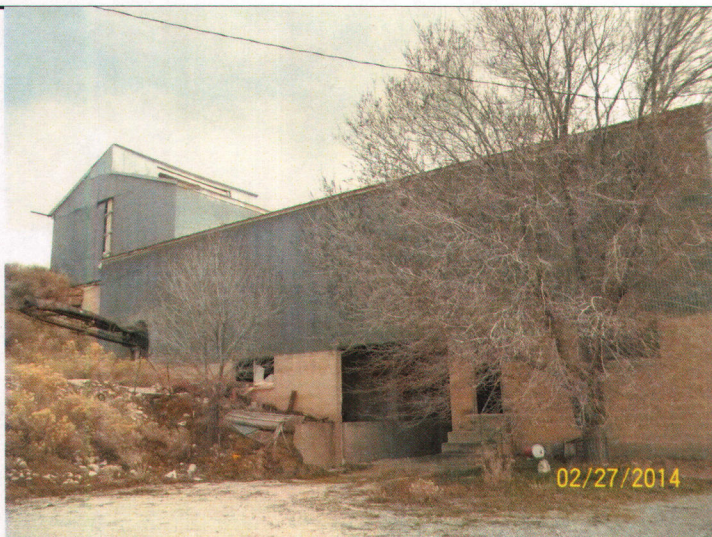
Cedarstrom Calcite Mine abandoned facility building.

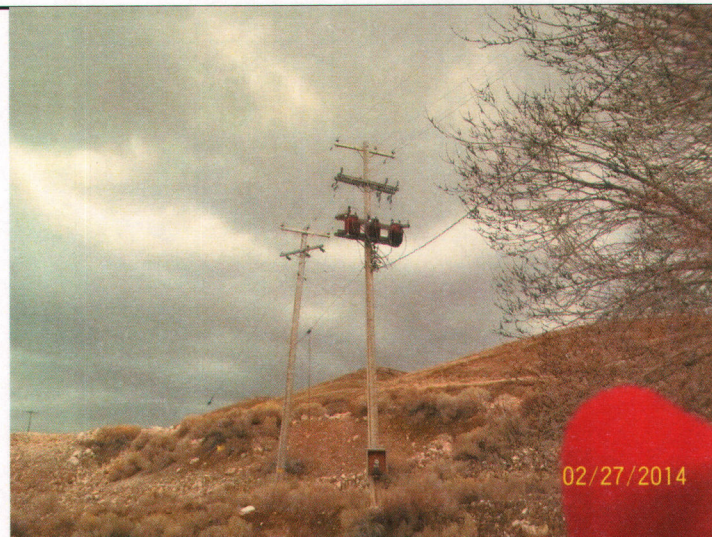
Three transformers were noted on the property. They had a blue label indicating they were PCB-free, but they did appear to be very old.

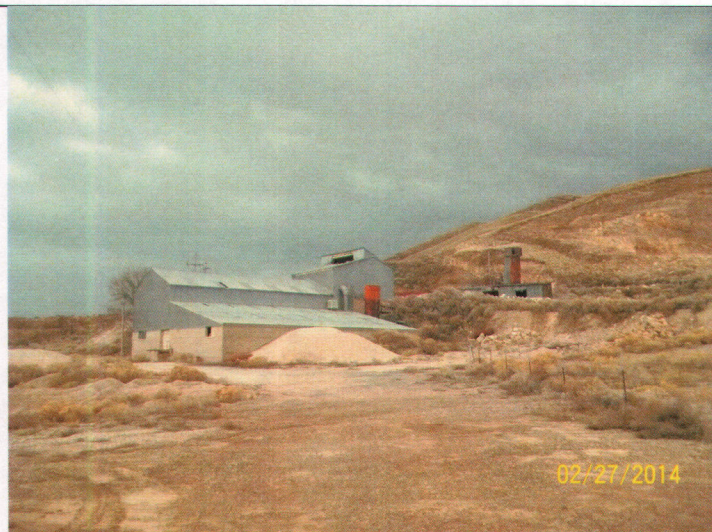
View of the facility and out buildings to the west facing south.

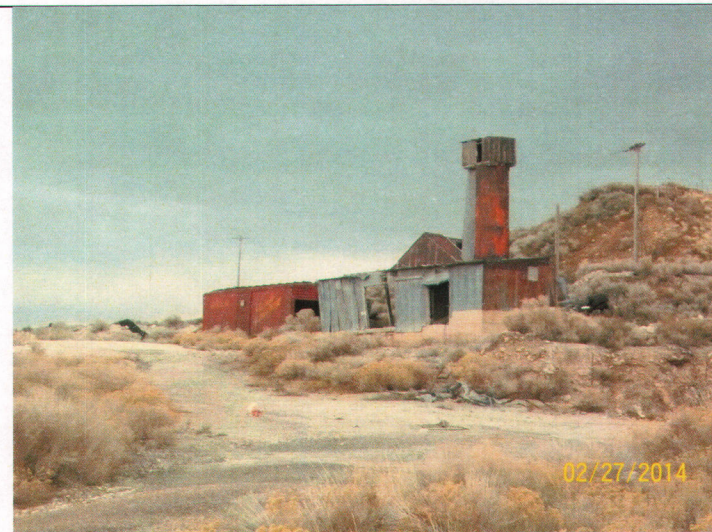
Buildings contained lots of scrap metal and abandoned equipment. Some rusty drums and 5 gallon buckets were also observed.

Unsecured portal and shaft areas are a public safety hazard. Access to the portal and shaft areas need to be secured right away. Demolition costs need to be included in the bond calculations. Ames is in the process of updating the bond amount. Requested to be notified by Ames when reclamation work is to begin this year so that I can be present on site during the work. Update directive with the revised bond costs.

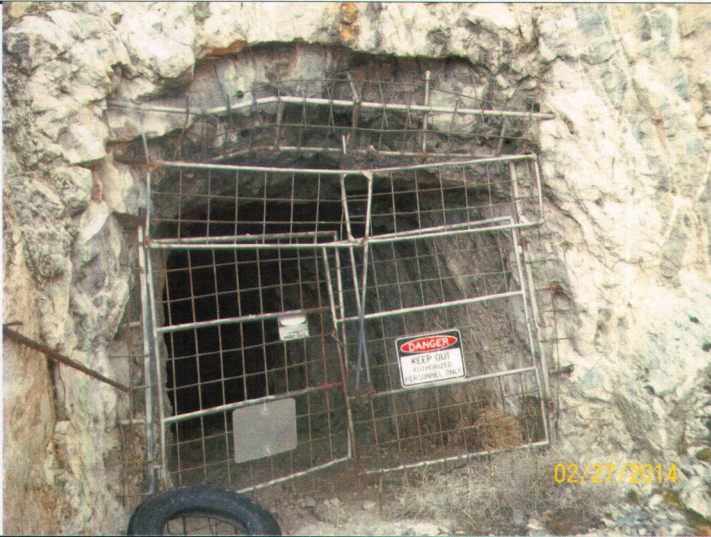
The gate into the underground portal was not secured at the bottom.

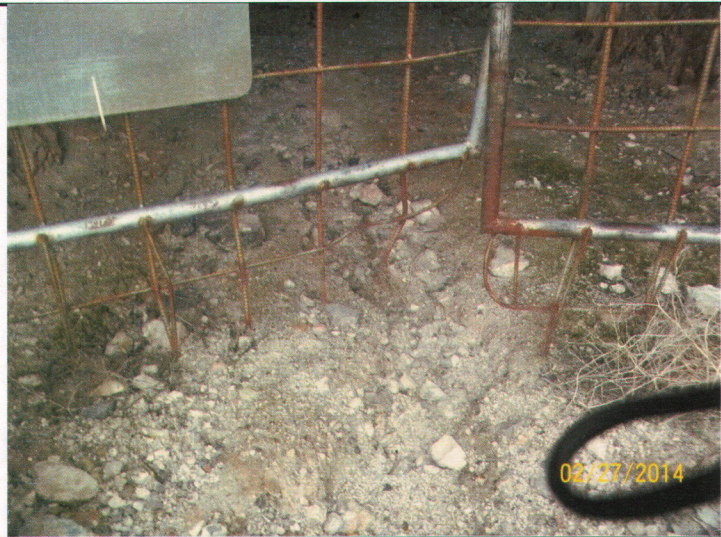
Close up of the unsecured gate. It would be easy for a person or wildlife to crawl underneath this space.

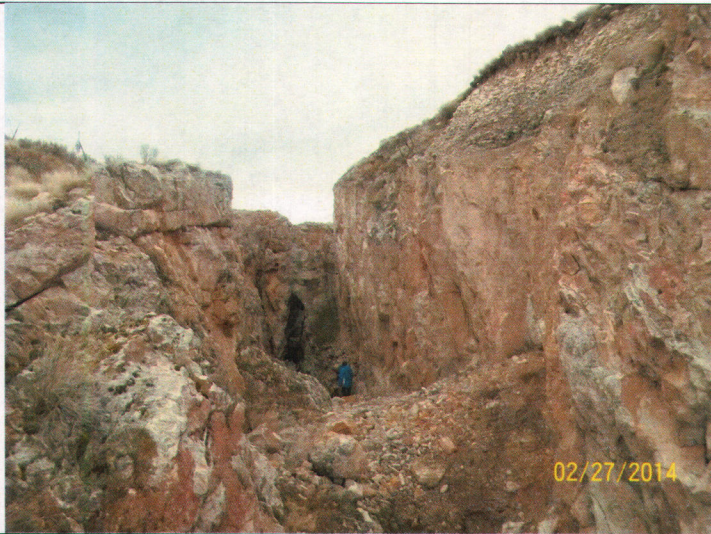
Along the trend of the calcite vein.

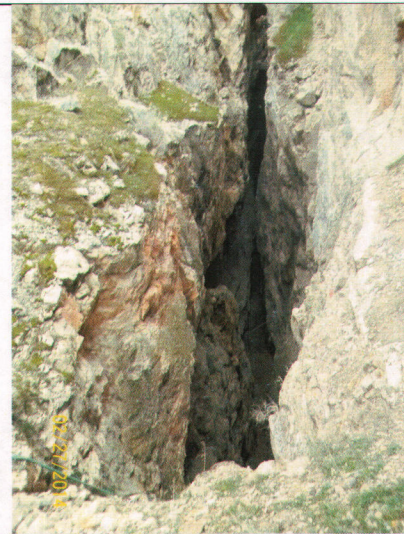
The mined out area extended vertically and appeared to be at least 50 feet down. This area should also be secured as it presents a public safety hazard.
